THE PRIORY OF ST NICHOLAS GREAT YARMOUTH

Stephen Heywood FSA. November 2006

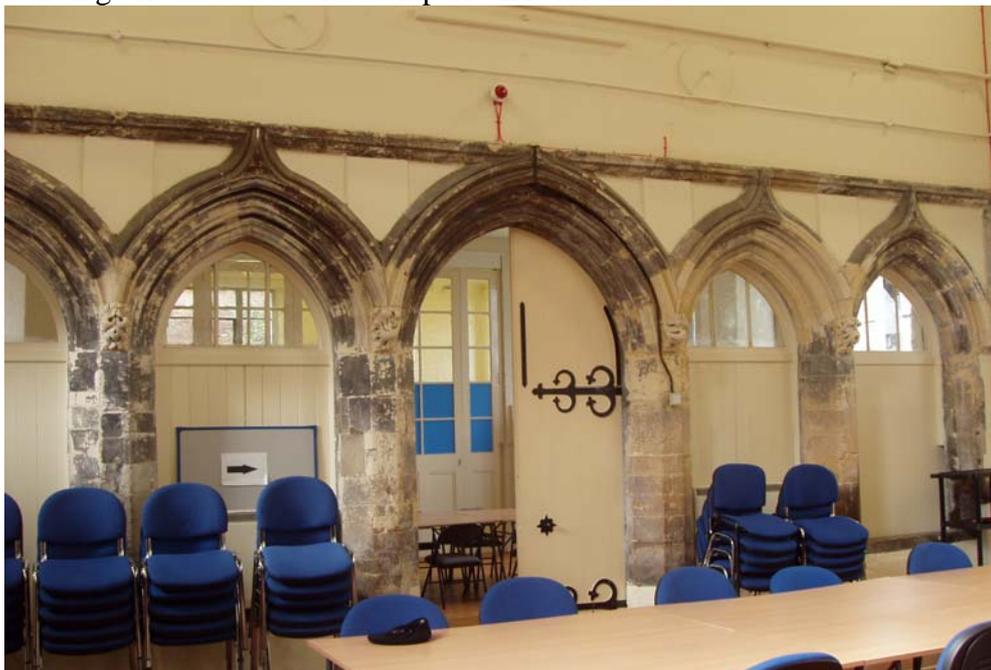
The attached engraving (after J S Cotman?) shows the state of the screen when the building served as a stable. Comparison is informative.

The engravings reveal that the elaborate label stops, as convincing as they may appear, are part of the Victorian restoration.

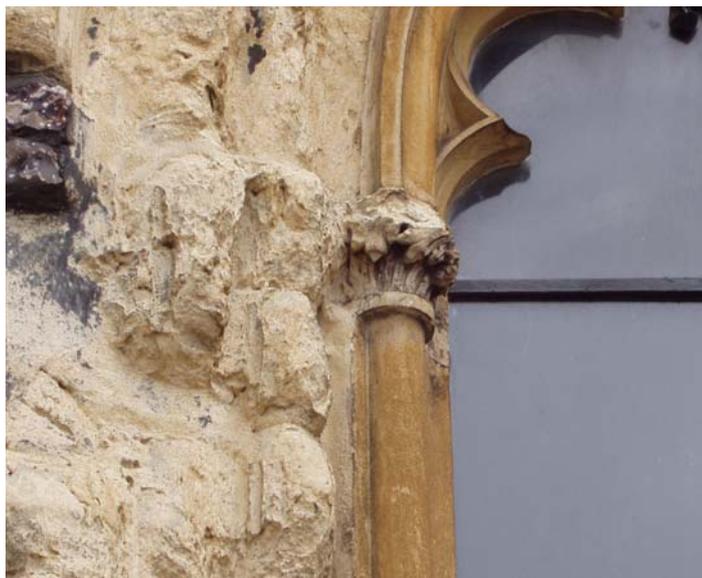
Retained C14 seaweed capital

There are four large traceried windows which light the hall. They are contemporary with the screen and contain restored tracery within the original moulded reveals. The tracery no doubt reflects the original and in fact incorporates some of the original little carved capitals.

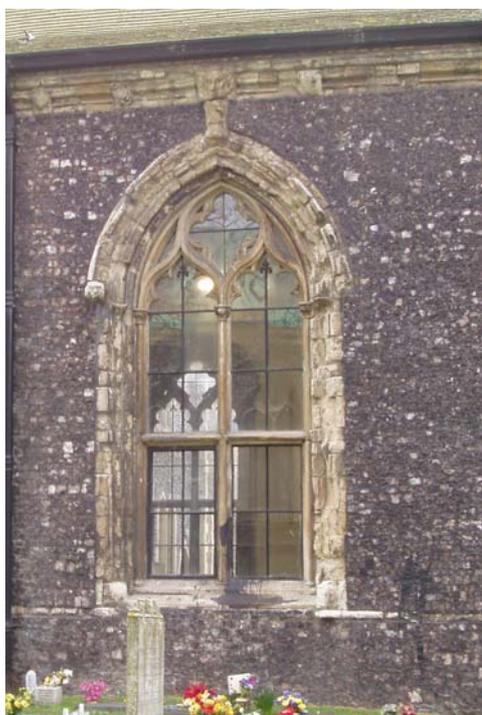
One of the most striking features of the tracery is the presence in each window of a transom which is not normally found until much later and forming part of the tracery proper in the head of the window. If it is not a Victorian invention its function could have been to disguise an internal division of some sort. The transom used as a disguise can be seen on the facade of Binham Priory where the aisle windows are divided by a transom to disguise the vault which traverses the window. There is no evidence here that any such division existed. However, the Cotman etching does give the impression of a floor/ceiling directly above the level of the screen (see below).

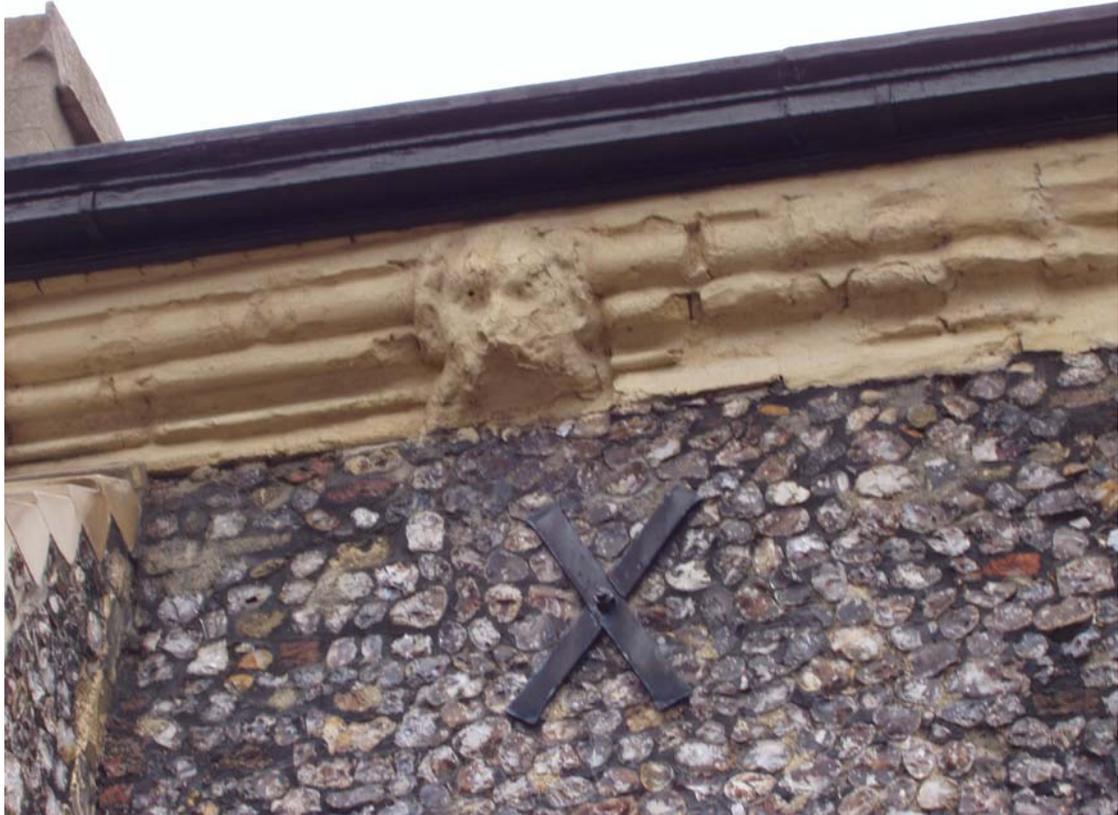
Cornice to south side

The moulded reveals are in a poor state and there have been various attempts to protect the ashlar from erosion. Most of the windows have had hood moulds introduced which has compromised seriously the original profiles of the openings. However, it is possible to see the original mouldings especially on the east window of the north side where the hood of the window finishes with an ogee topped with a fleuron which penetrates the moulded cornice. The cornices are exceptional pieces of sculpture with the bold mouldings interrupted by gargoyles and bosses. The gargoyles, which are, of course, for discharging rain water, suggest that the cornices supported a parapet originally and that the roof was probably shallow pitched.

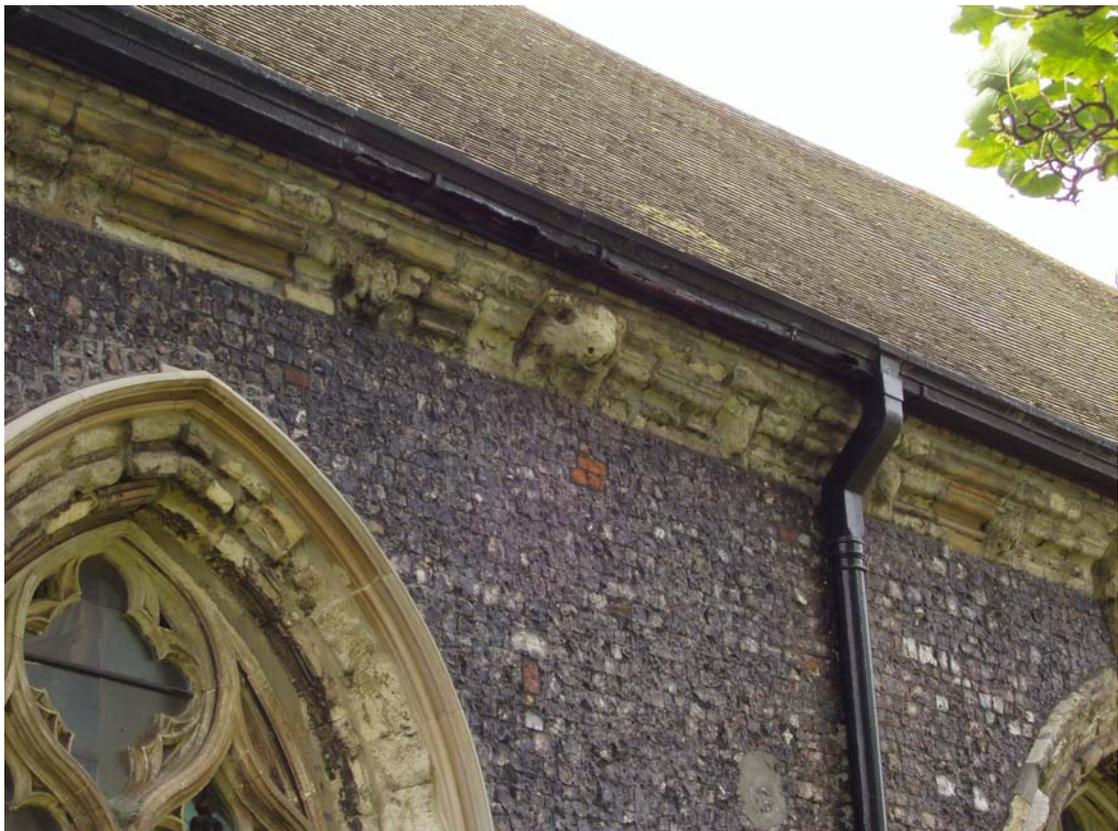
Cornice to north side

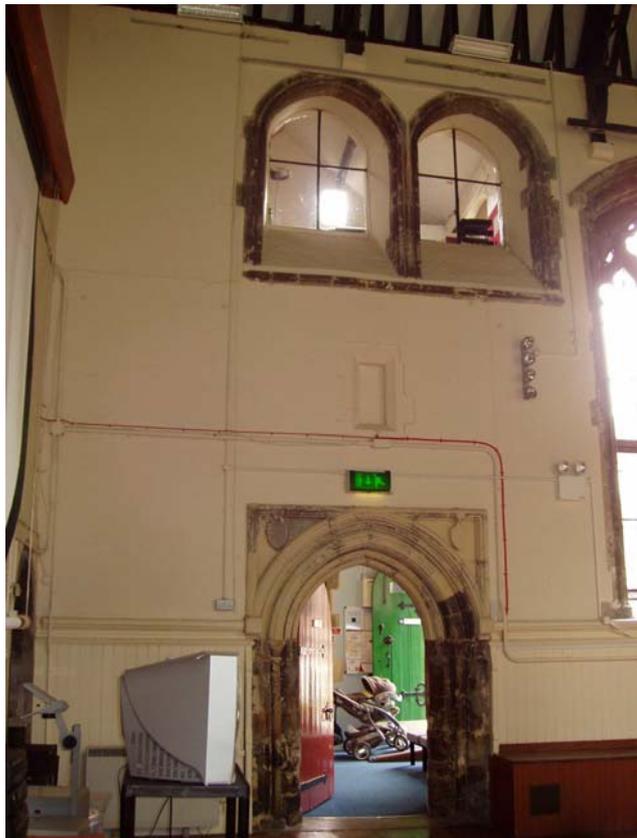
On the interior at the west end are some openings on the south side which may have led to the prior's lodging. It now leads into a Victorian Gothic revival building. In the corner of the entrance lobby, an apparently medieval quoin is revealed. It is not clear what this relates to but it may be a remaining fragment of the Prior's lodging which was demolished in the 17th century. The doorway is late medieval with moulded

reveals and nook shafts. A square hood forms spandrels which are decorated with shields. It will be noticed that the doorway is treated as if it was an exterior doorway announcing a space rather than retiring from one. Above the doorway is a small blocked loop which may have been a squint. Above this is a kind of clerestory with a pair of unsplayed arched windows with acutely sloping sills. Were these just for light when next to the far larger hall windows? It seems more likely that they overlooked the hall and may have been for musicians with the large openings designed for letting sound out rather than light.

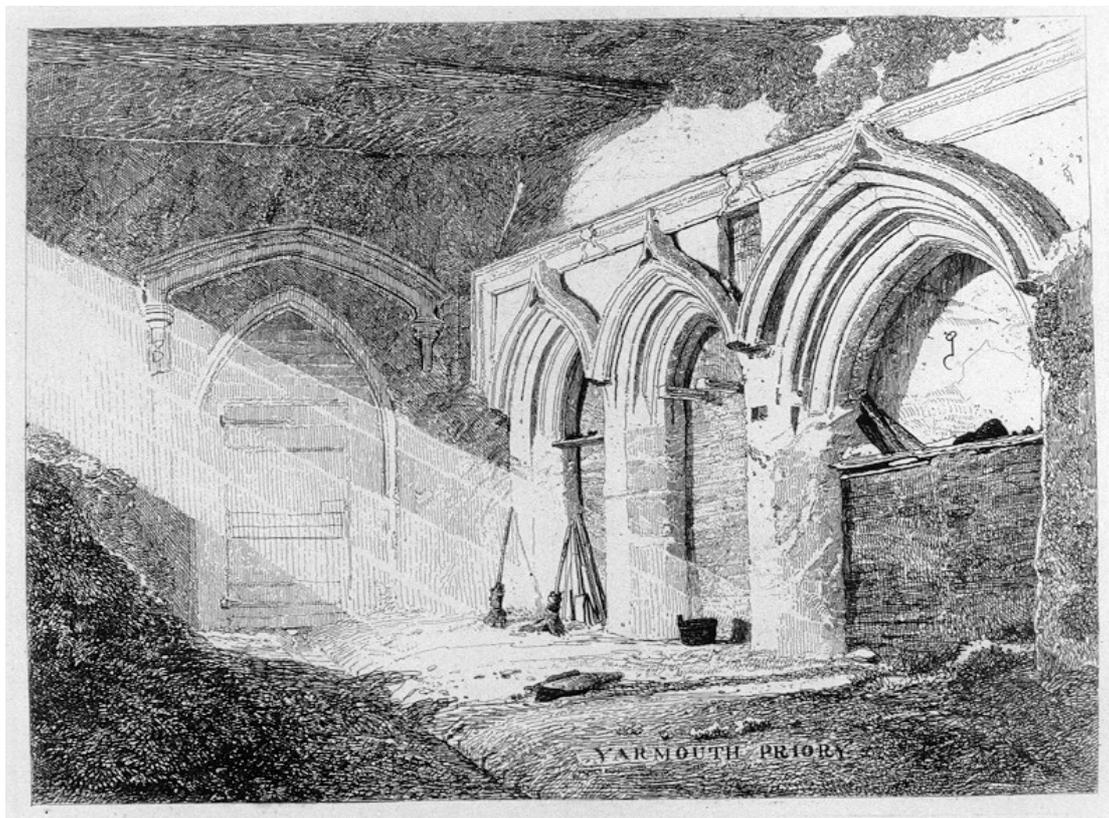
Etching by J S Cotman. 1818
