THE CHURCH OF ST SAVIOUR SURLINGHAM

An Architectural History

Stephen Heywood FSA
Heritage and Landscape
Department of Planning and Transportation
Norfolk County Council

January 2008

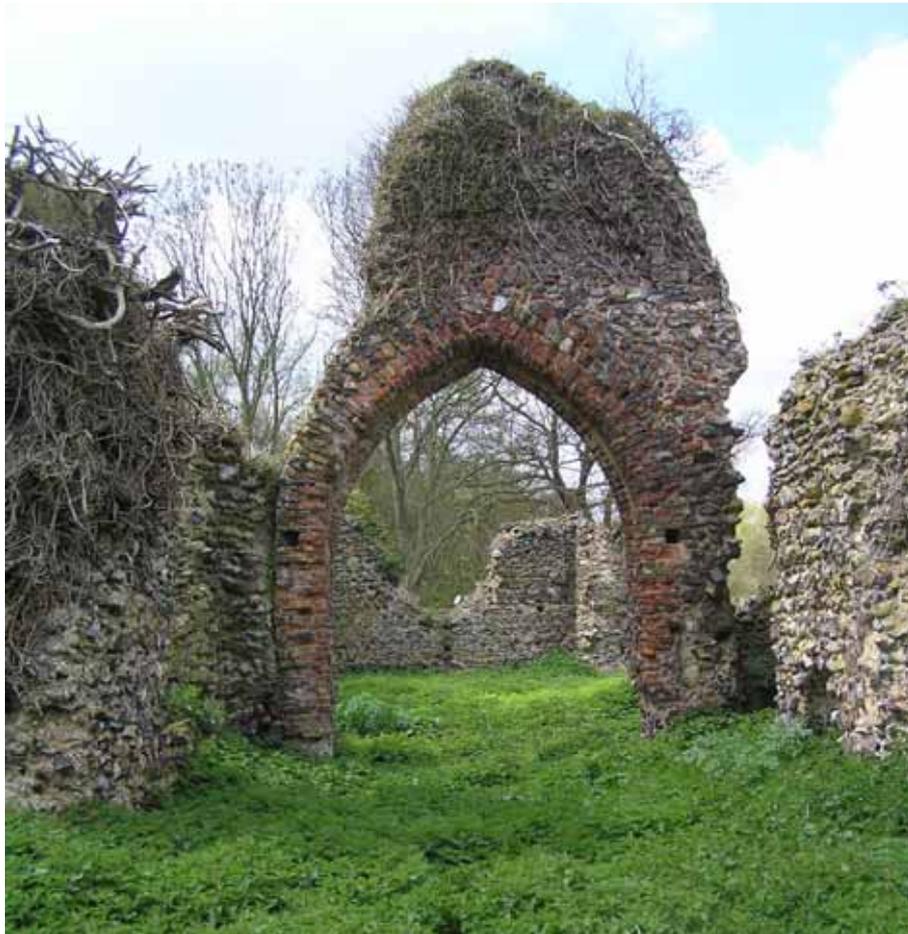
Fig. 1. Interior looking west

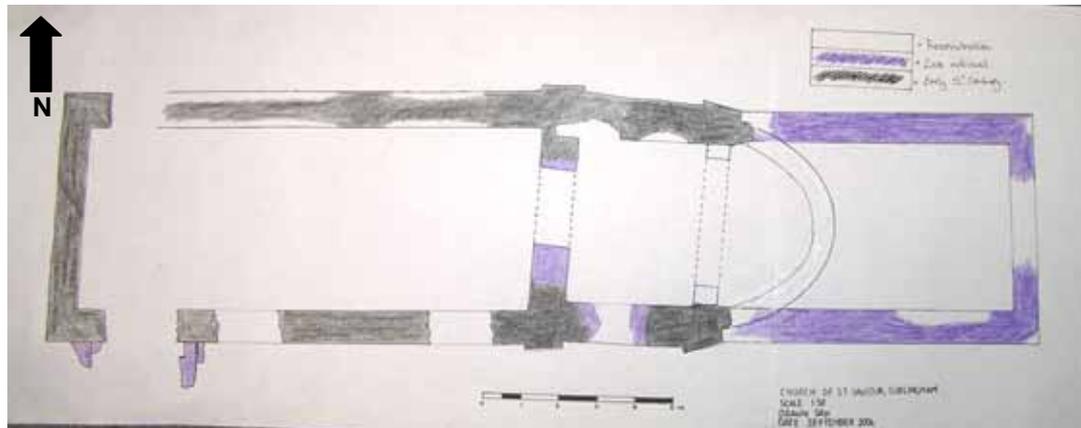
Fig. 3 Plan

The plan of the church had become clearly discernable in 2004 when the ivy was cut back and sections of the ivy trunks removed (Fig.3). The plan is of an aisleless nave with a choir area to its east entered through an arch. The arch is of later fabric but the original flint responds for an arch survive behind the 15th-century brick (fig. 1). At the eastern side of the choir was another arch where the responds have been cut away. Careful examination reveals breaks where the flint courses are discontinued and the

The plan (fig. 3) shows that the area defined by the arches has its north and south walls wider than those of the nave and furthermore the arches are reinforced by shallow buttresses. This has led

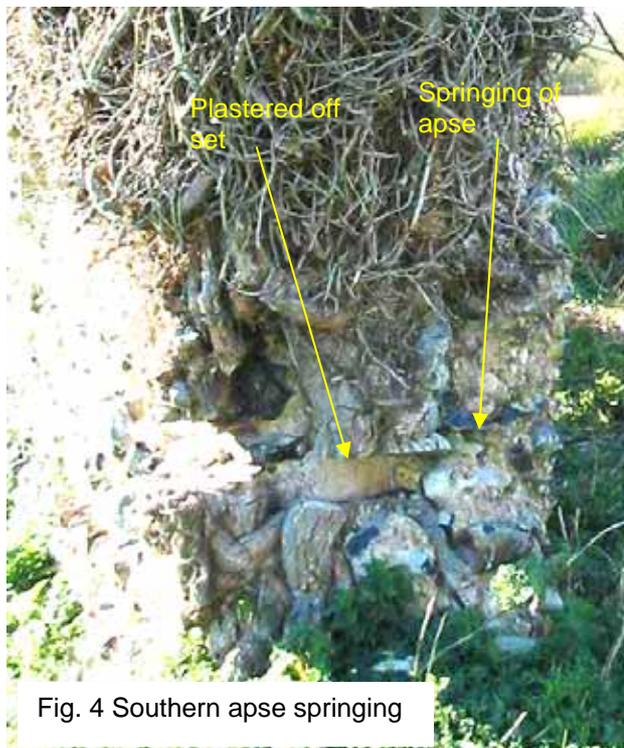
Fig. 4 Southern apse springing

slight roughness discernable leaves no doubt of the former responds. They were cut away when the chancel was rebuilt and extended in the 15th century. An apse terminated the original building. The springings for the apse and the plastered offset were noticed for the first time by the removal of a section of ivy trunk and by the falling away of the remains of the late medieval chancel where it abuts the original work (Fig. 4).

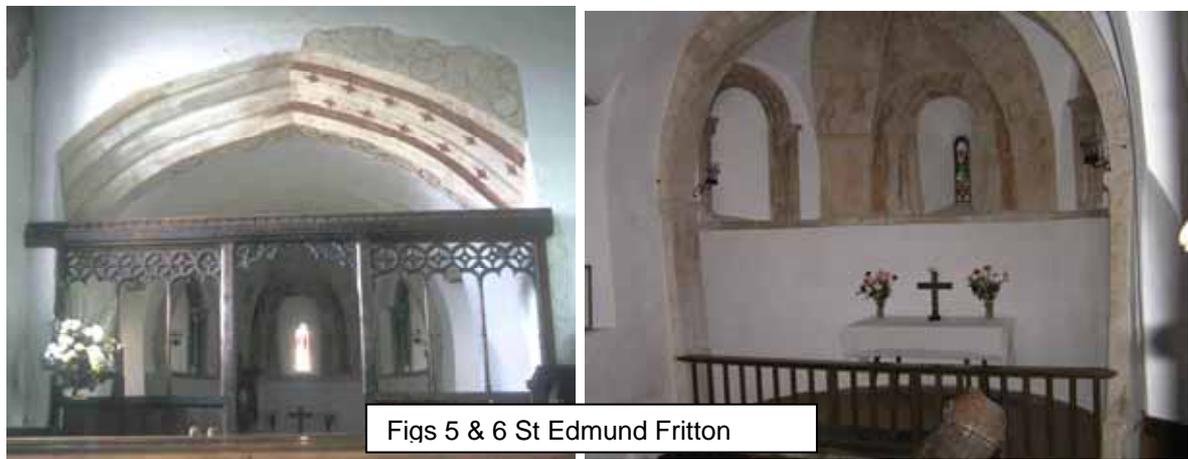
The chancel arch in this example has been altered but the original barrel vault and semi-dome survive.

The conclusion is that there was no tower and that the wide walls were to support a stone barrel vault and the apse would have had a semi dome. An arrangement such as existed at St Saviour's survives locally at Fritton near Great Yarmouth (figs 5 & 6).

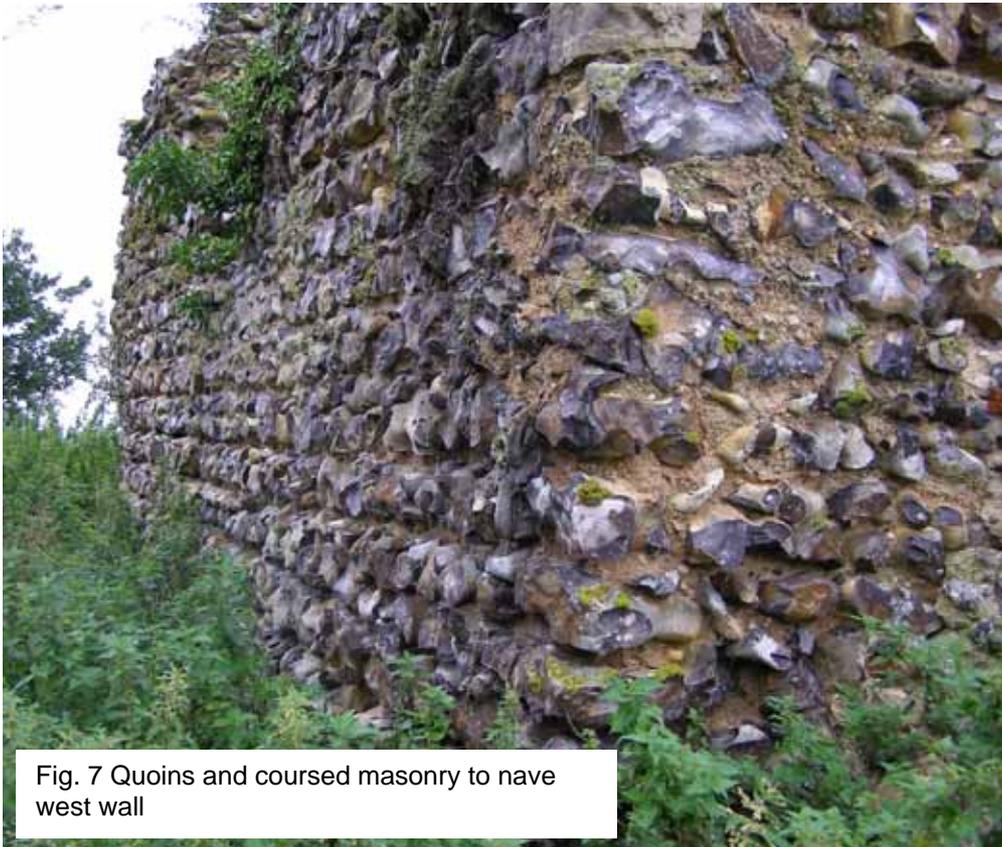
Fig. 7 Quoins and coursed masonry to nave west wall

The facing of the Norman walls is of large flints roughly broken into blocks and laid in very even courses. Free stone has not been employed due to the expense of importing stone from other regions and the quoins and dressings are of roughly knapped large flints. The cores of the walls are a mixture of mortar and flint rubble (fig. 7). The Norman masonry has received no consolidation or repointing since it was built about 900 years ago. Careful observation reveals hairline horizontal cracks every few courses representing the levelling off on the top of the section of wall reached during building. The mortar hardens before the wall is continued and leaves the barely perceptible 'lift lines'. The careful plotting of these lines would reveal the different stages in the building of the church (fig.8).

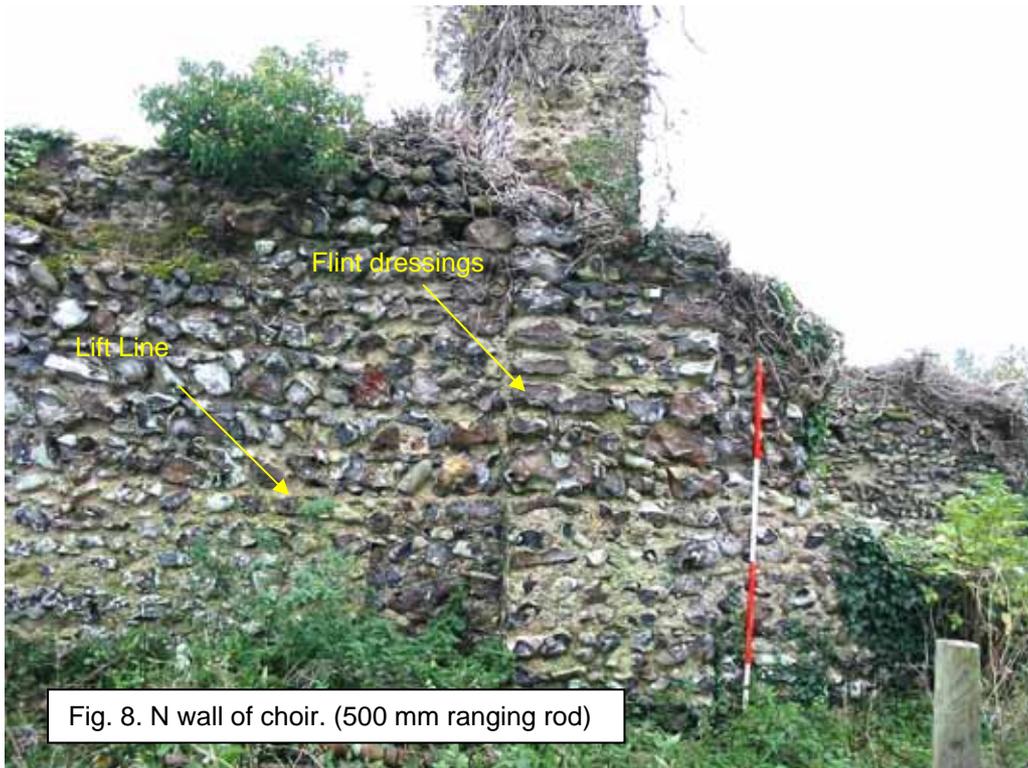
Fig. 8. N wall of choir. (500 mm ranging rod)

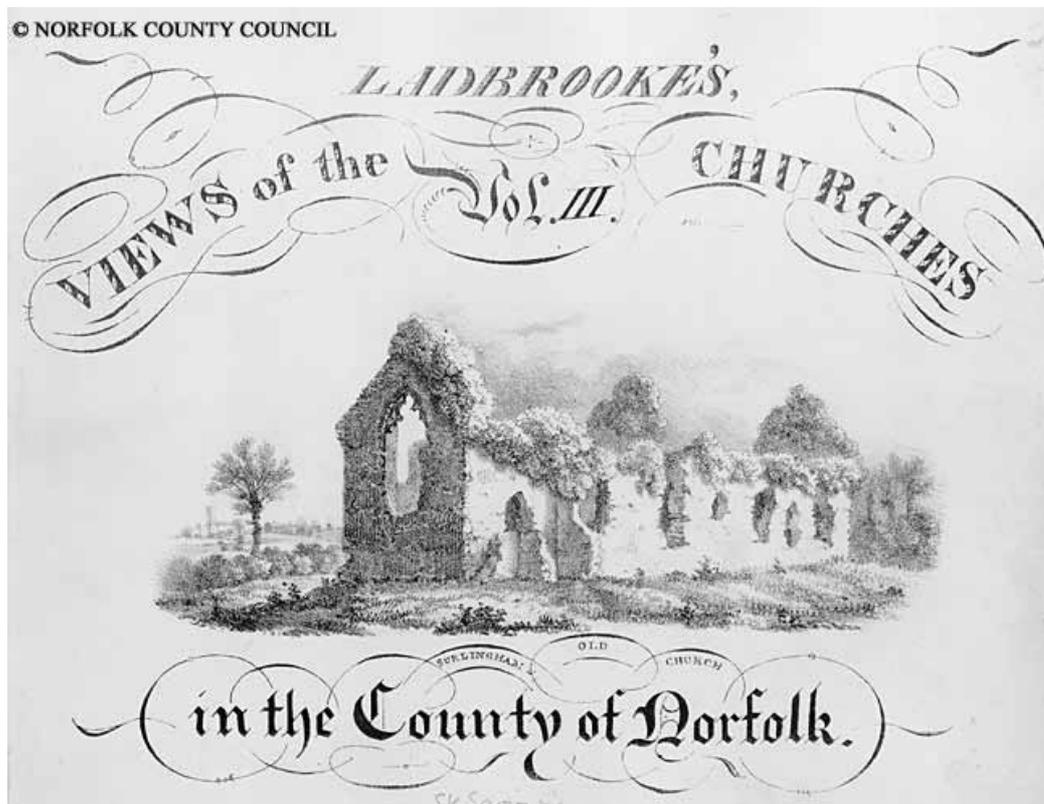
Fig. 9 Ladbrooke's lithograph. View from the north east. 1824

Ladbrooke's view of St Saviour's shows that there was much more of the church surviving in the 1820s than there is today. Although clearly an attractive ruin the walls are shown to be standing up to the former eaves level and the gables are quite distinct. The engraving shows the remains of a porch to a priest's doorway in the north wall of the chancel and some tracery remaining in the east window. The fact that this lithograph of a ruin was chosen for the frontispiece of Ladbrooke's third volume of Norfolk Churches shows that ruins have a special fascination for his public and this romantic association remains strong to this day.
